# Petroleum Joint Depot identifies jet fuel leak on 24-inch pipeline in Egypt

INLINE CONFIRMATION OF CONTAINMENT TOOL USED TO PINPOINT LEAK LOCATION

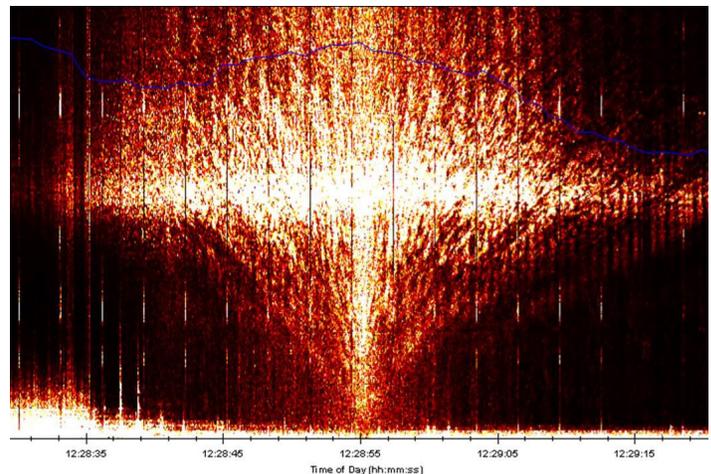
This image shows the acoustic signature of the leak identified on the jet fuel line, which is clearly distinguishable from other sounds.

The SmartBall tool was inserted into the pipeline using a 14-inch tee spool for the 0.8-mile inspection. The entire inspection was completed in less than an hour with the pipeline operating with a flow of roughly 1.6 feet per second at 190 psi. After on-site review of the data, a suspected leak was identified. After pinpointing the location within 5-feet, the operator was able to excavate, verify and repair the leak.
